# Manhole Inspection Summary

Manhole # S21K1\_025MH

Insp Date: **4/25/08 11:23 AM**

**Location** Address: **2618 stranden rd**

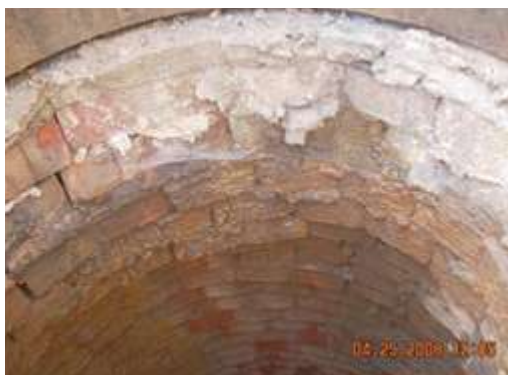
Defect 4

Infiltration: ☐ None ☒ **Joint** ☐ Cracks ☐ Mortar ☐ Roots ☐ Wall

infiltration @ corbel/chimney joint

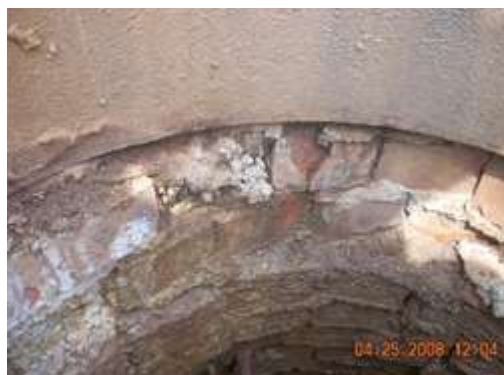
Defect 3

Condition: ☐ Sound ☒ **Cracked** ☐ Root Intrusion ☐ Loose Brick ☒ **Deteriorated**

cracked/deteriorated chimney bricks

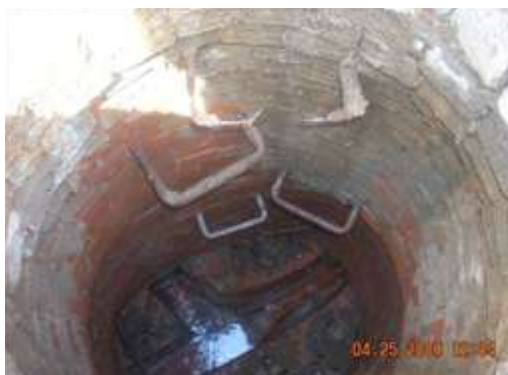
Defect 2

Count: **4** Missing: **1** ☒ **Corroded**

corroded and missing steps

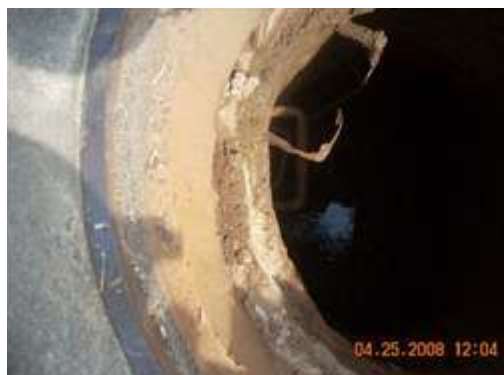
Defect 1

Offset: **1** (in.)

frame offset

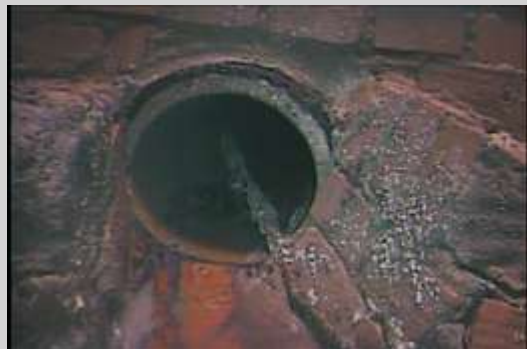
9 O'Clock Inflow

Deposits: ☐ None ☐ Mud ☐ Sludge ☒ **Debris** ☐ Grease

Silt Depth: **2** (in.) Deposits Extent: **Light**
